# DuPont global PV reliability

2020 Field analysis

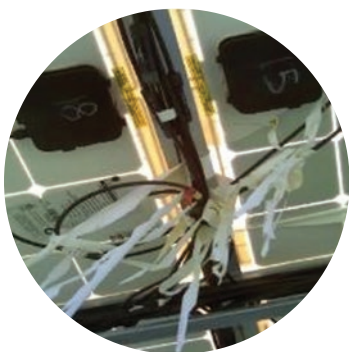
**5 years**  
Eastern Canada

There have been observed many examples of widespread backsheet through-cracks.

- These failures are prevalent along busbar ribbons, but with continued weathering can extend to cell gaps and other regions.
- Arcing and shorts often lead to localized burn-through and sometimes full module fires.
- Reported inverter tripping and ground faults.

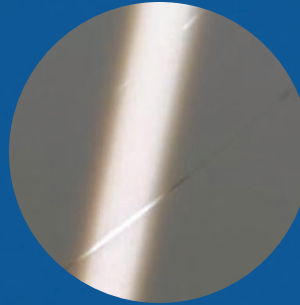
A photovoltaic plant in France discovered that, after 8 years of use, performance of their modules was declining year over year and that many modules were displaying widespread backsheet cracking. This had led to a degradation of insulation resistance (IR) in the solar modules over time, leading to unsafe working conditions as a result of electrical hazards. All PA backsheets and 10% of PVDF backsheets exhibited cracking.

**Widespread  
backsheet cracking**  
PVDF

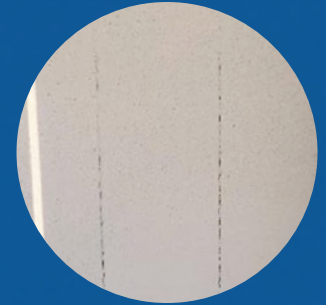
**Widespread  
backsheet cracking**  
PA

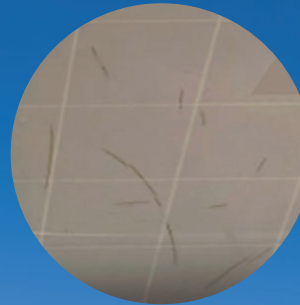
One solar field in Arizona, USA utilized a mixed bill of materials. After 7 years of use, widespread cracking was found in PVDF backsheets. The entire field needed to replace modules in order to maintain operation and energy production and, as a result, sustained multimillion-dollar losses. No defects were observed in modules made with Tedlar® PVF-based backsheets.

**Widespread  
backsheet cracking**  
PVDF

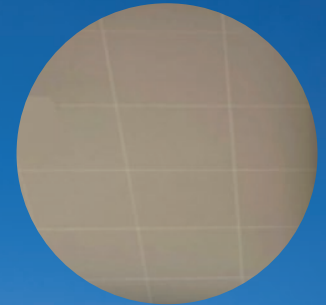
**No defect**  
Tedlar® PVF
