# DuPont global PV reliability

2020 Field analysis

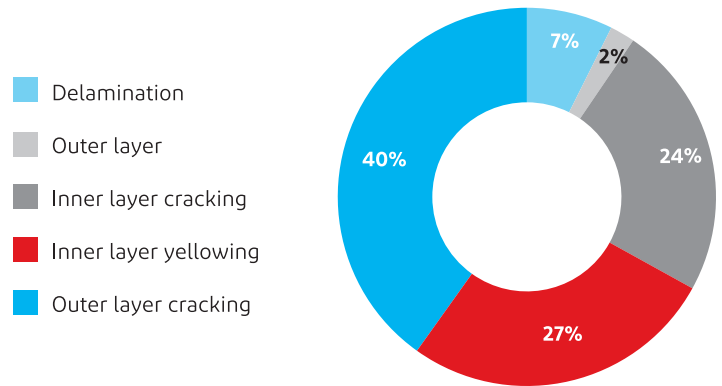
## Backsheet defects by degradation mode

- Total module defects: 30%
- Total backsheet defects: 16%
- Total cell/interconnect defects: 14%
- Cracking comprises 64% of all backsheet defects

- Backsheet: outer-layer (air side) and inner-layer (cell side) cracking, delamination, yellowing
- Cell/interconnect: corrosion, hot spot, snail trails, broken interconnect, cracks, burn marks
- Encapsulant: discoloration, browning, delamination
- Other: glass defects, loss of anti-reflective (AR) coating, junction box

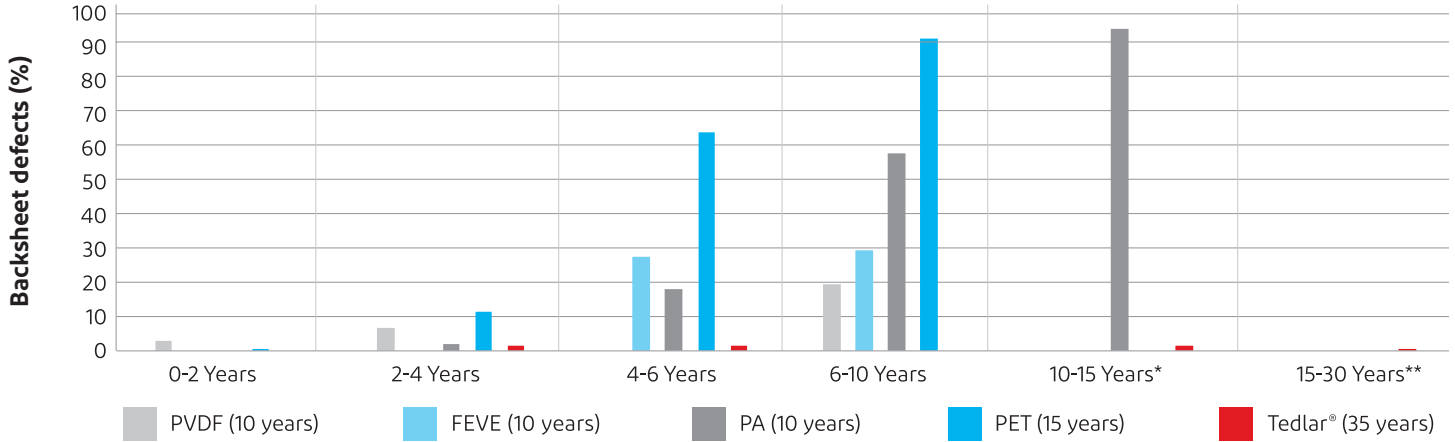
Defect rates in PVDF, FEVE, PA, PET and Tedlar® backsheets

DuPont™ Tedlar® polyvinyl fluoride (PVF) film-based backsheet maintains the lowest defect rates—even after 35 years in the field.

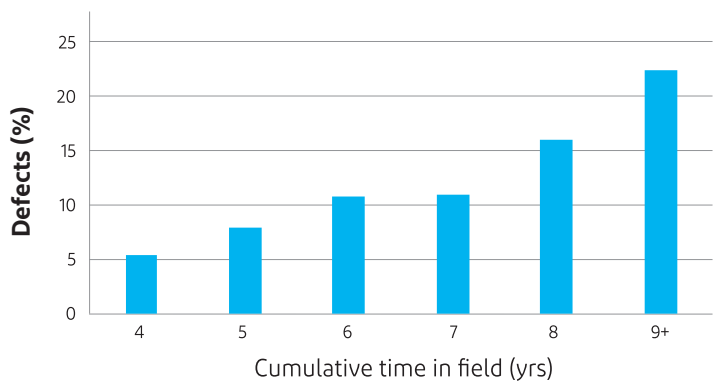
PVDF backsheet cracking defect rate

There has been observed nearly a four-fold cumulative increase in PVDF outer-layer cracking defect rates, from 5% to 23% between year 4 and year 9 after installation.
